# Weekly Construction Report

## Hatchery Creek Design/Build Project

<b>Time Period (two weeks):</b>	October 12-24, 2015	<b>Project No:</b>	1305
<b>Rain Days/Weather Conditions:</b>	Rain 0.3" on Tuesday, Oct. 13 <sup>th</sup> and 0.2" on Saturday, Oct. 24 <sup>th</sup> (Burkesville gauge). We did not work on those days.		
<b>Personnel on-site:</b>	<i>EcoGro/Ridgewater:</i> Tom Cutter, Eric Dawalt, Jim Hanssen, Larry Mounce, Brad Redmon, Chad Relinski, Randall "Mokie" Starns, Randall Starns, Jr., Sherri Arthur Trucking-John Arthur.		
<b>Equipment on-site:</b>	Komatsu PC 360 excavator w/ hyd. thumb, Komatsu PC 160 w/ hyd. thumb, Komatsu PC 210 excavator, Komatsu PC 240 excavator, Terex TA27 articulated off-road dump truck, Bobcat T300 skid steer, & Morooka 2200 track dump truck.		
<b>Material deliveries to project site:</b>	<ul style="list-style-type: none"> <li>328 tons of spawning gravel (1,544 tons to date).</li> <li>462 tons of 24" + diameter rock from quarry.</li> </ul>

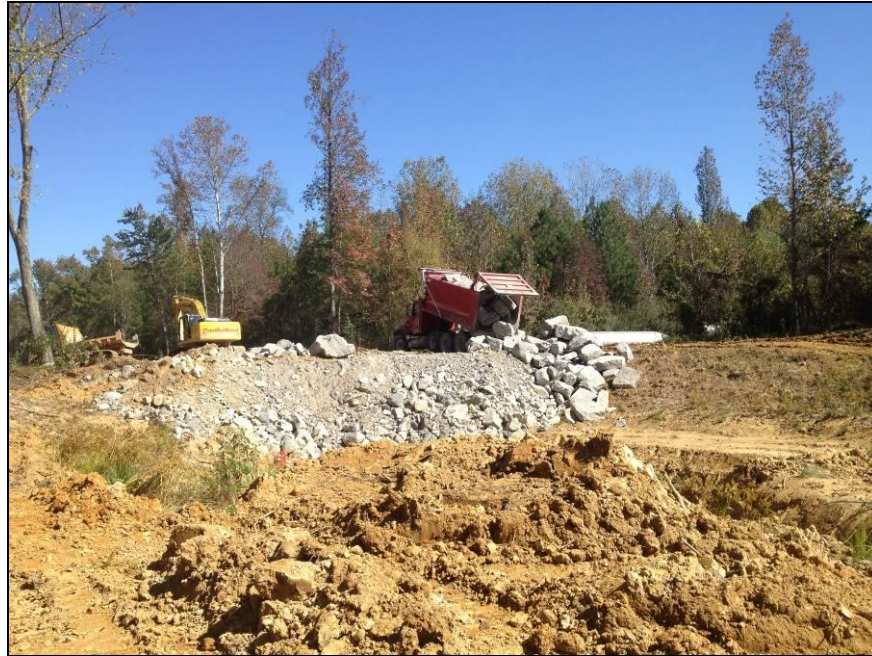
**Site #1: Boulders (24"+ diameter rock) being delivered. (Picture taken on Left Descending Bank (LDB) at ~Sta. 116+00 looking downstream).**

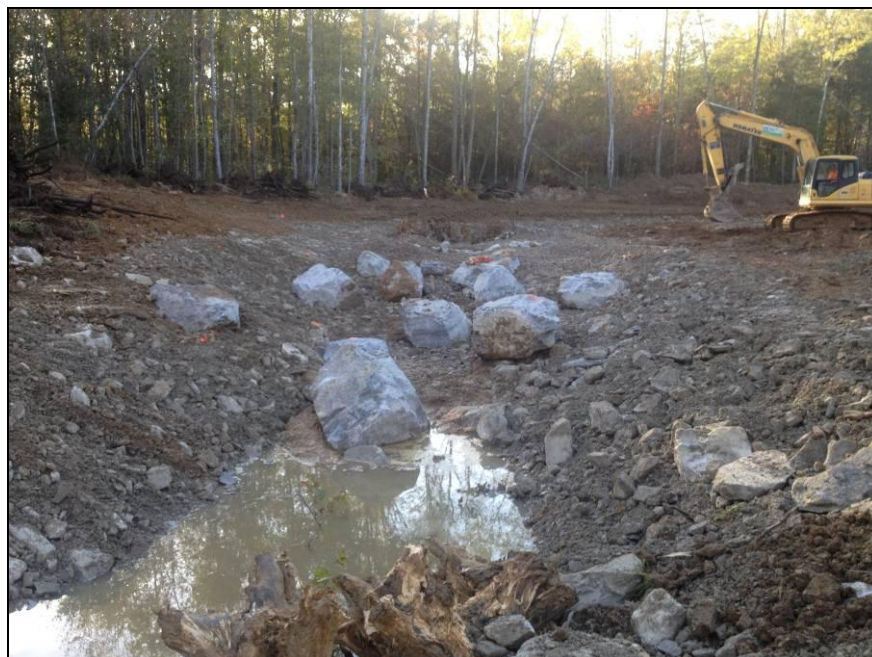
**Site #1: Boulders installed in run portion of channel for fish habitat. (Picture taken from ~Sta. 127+00 looking upstream).**

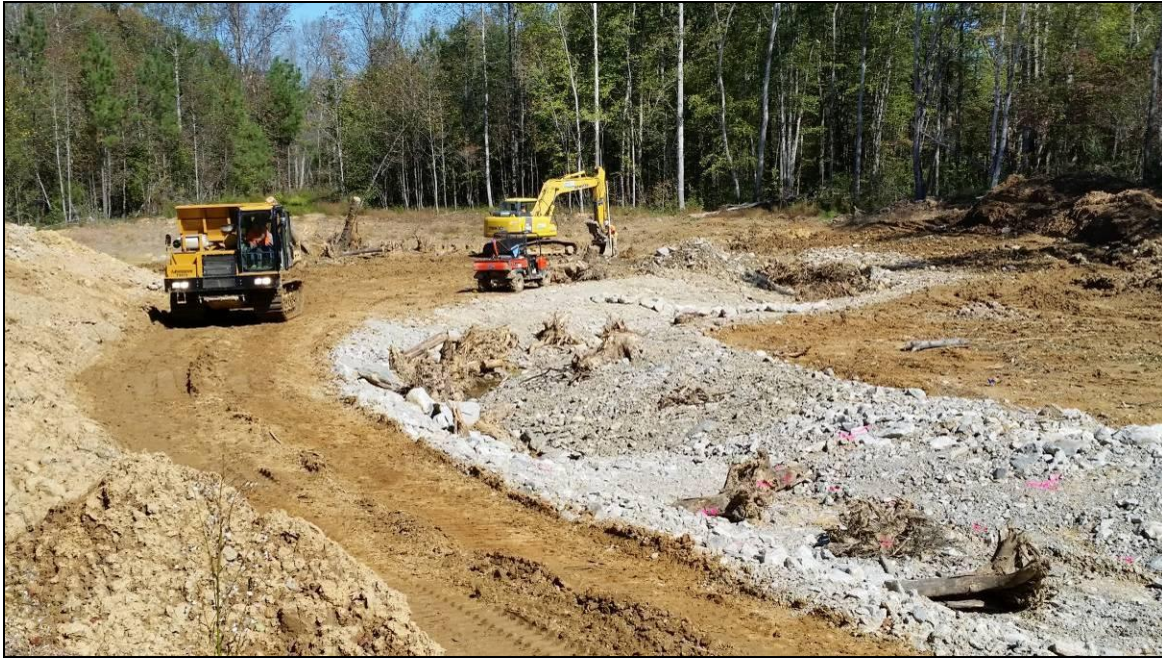
**Site #1: Constructed stream channel showing shot rock constructed channel with rootwads and logs installed for fish habitat. (Picture taken from LDB at ~Sta. 123+00 looking downstream).**

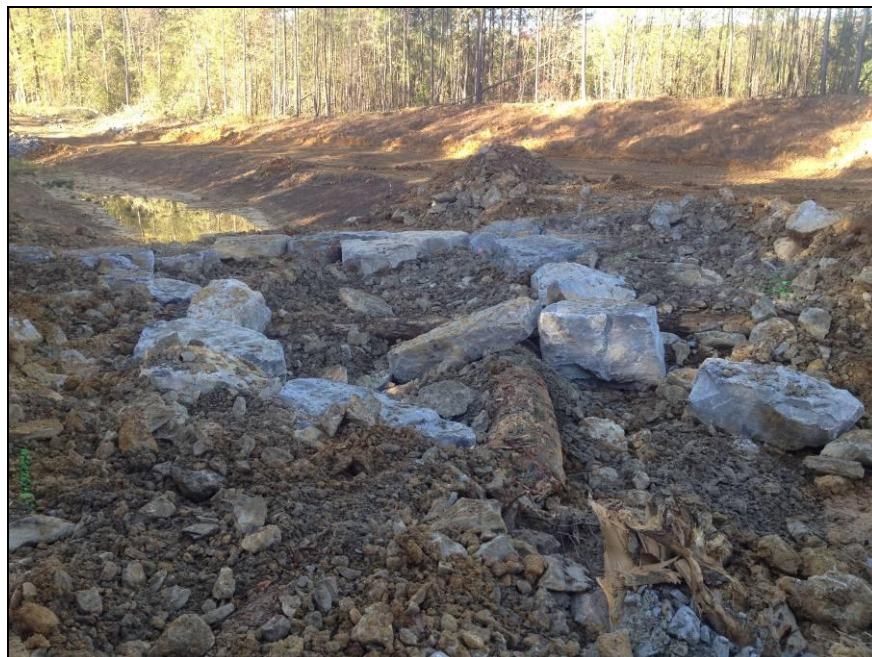
**Site #1: Log/Rock and Roll Riffle structure being installed for fish habitat. (Picture taken from ~Sta. 121+00 looking upstream).**

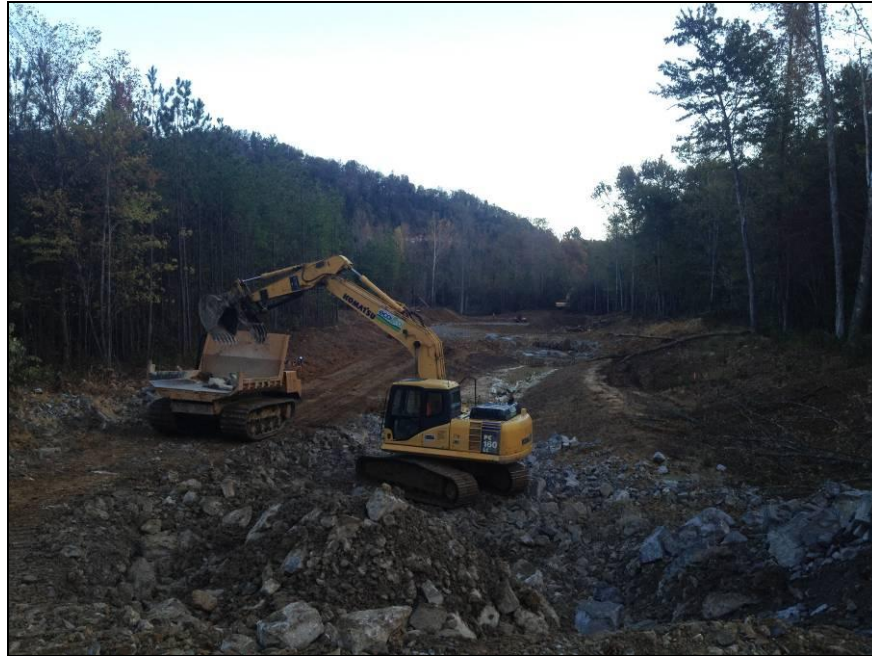
**Site #1: Shot rock being loaded in track dump truck. Excavated soil channel in background has not been covered with rock yet. (Picture taken from Campground Road at ~Sta. 118+00 looking downstream).**

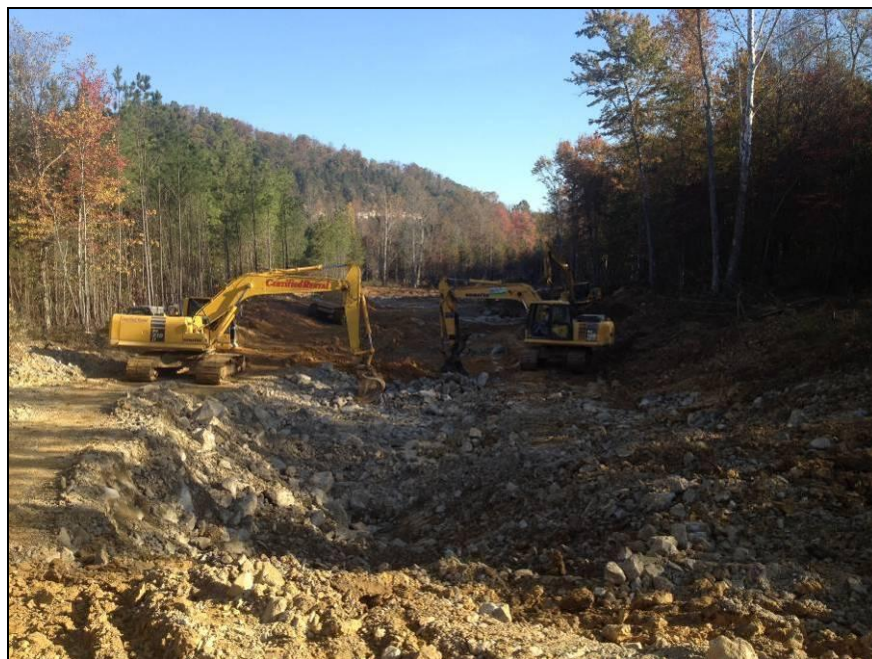
**Site #1: Installing shot rock over soil channel. (Picture taken from approximate same location as above).**

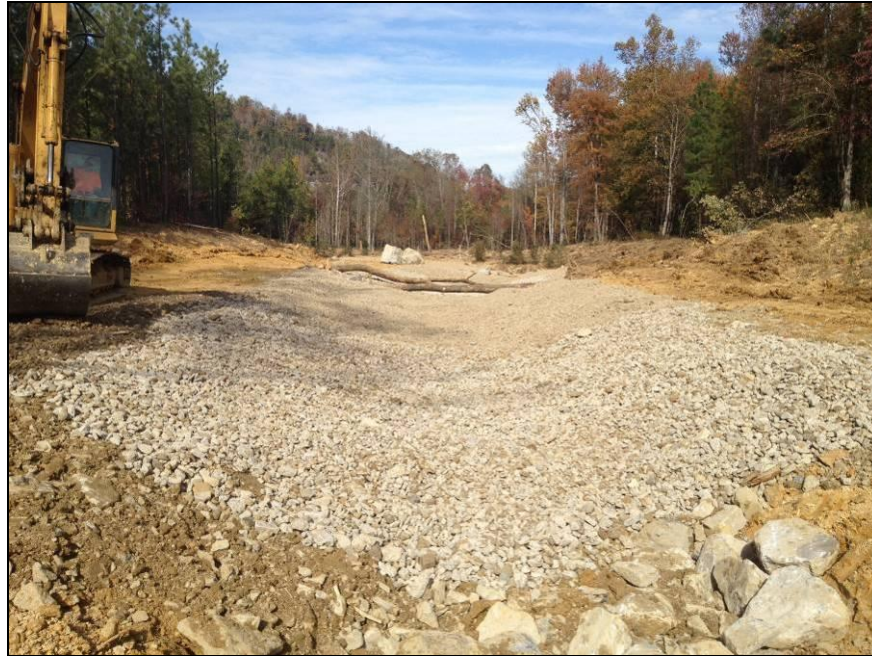
**Site #1: Spawning gravel installed in channel over shot rock in foreground. (Picture taken at ~Sta. 118+80 looking downstream).**

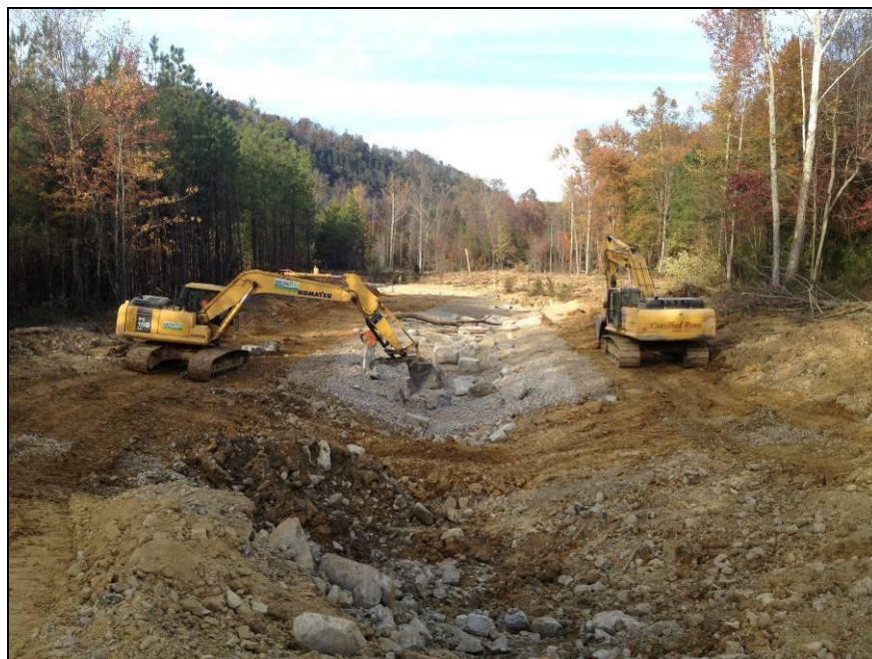
**Site #1: Installing boulders and logs over and in spawning gravel for fish habitat. (Picture taken from Campground Road at ~Sta. 118+00 looking downstream).**

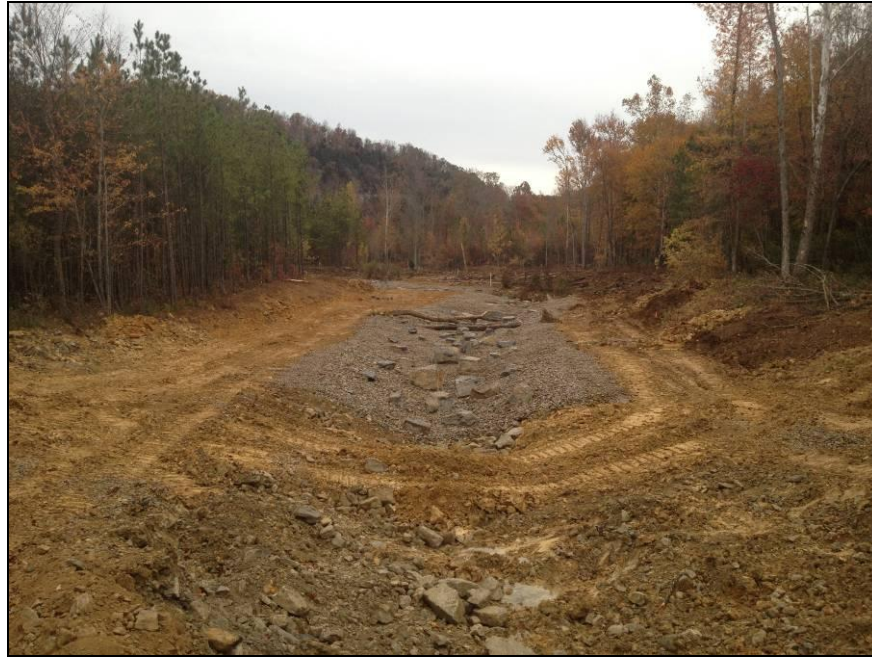
**Site #1: Banks on RDB of completed section of stream have been graded, stockpiled topsoil and wood has been spread, and on-site trees and shrubs have been transplanted next to the stream. (Picture taken from approximate same location as above).**

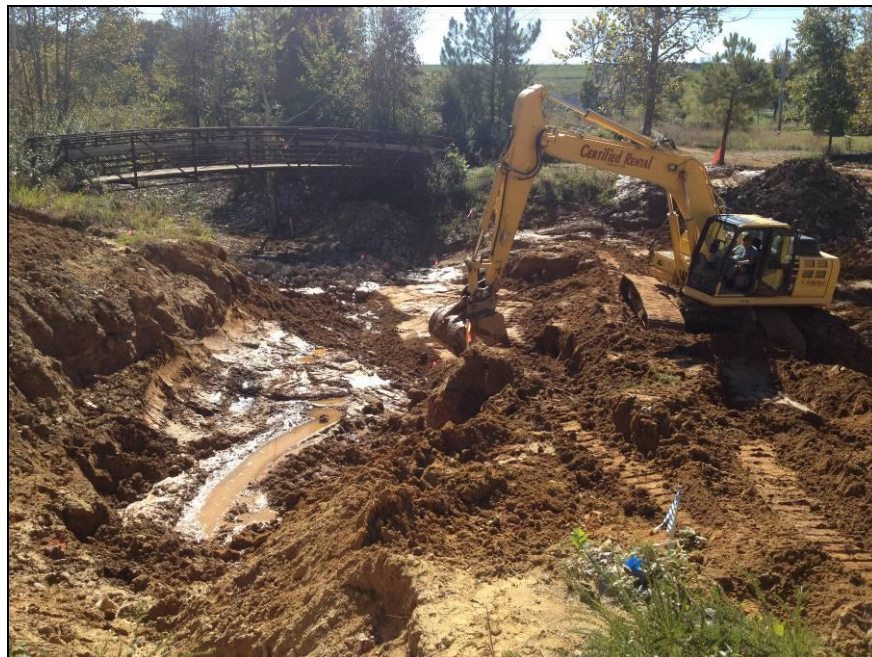
**Reach downstream of Migration Barrier: Excavating soil for channels and building soil subgrade of confluence bar. (Picture taken from at ~Sta. 107+00 looking upstream. Note location of Point of Curvature (PC) grade stake with blue and white flagging in bottom right corner of picture).**

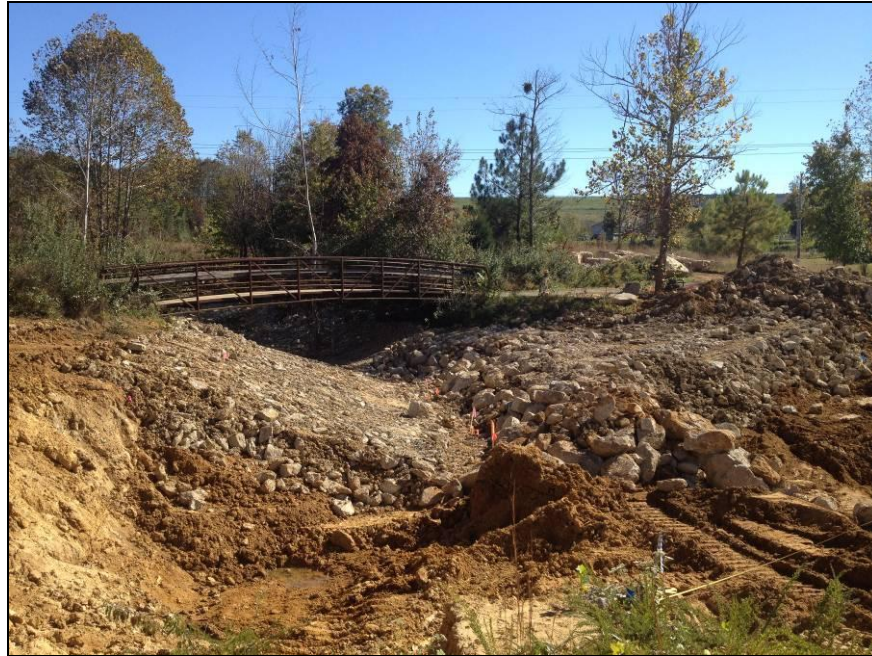
***Constructing ravine channel and confluence bar out of shot rock. (Picture taken from approximate same location as above).***

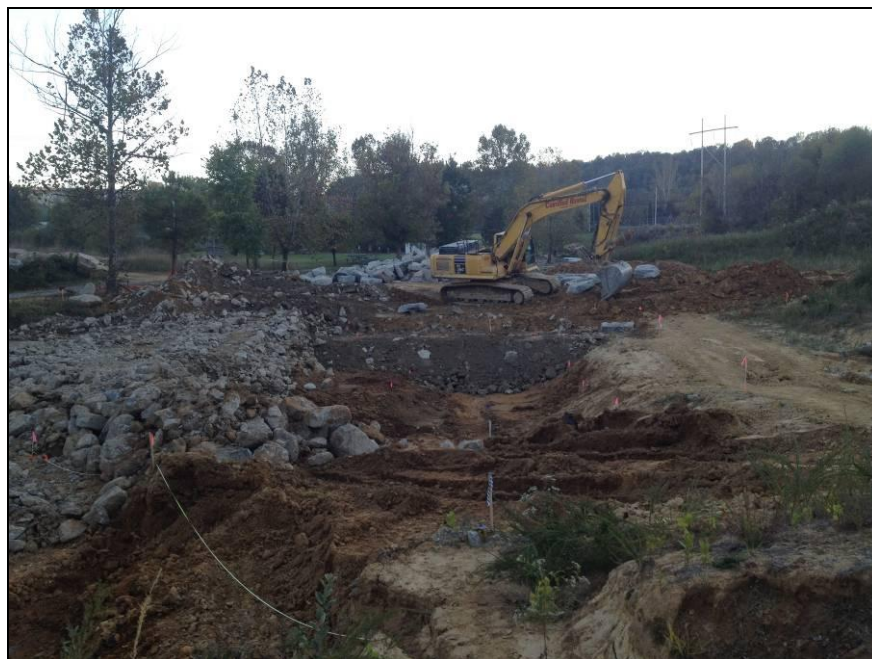
***Constructing shot rock subgrade for migration barrier splash pad in background. (Picture taken from ~Sta. 107+00 looking upstream. Note location of Point of Curvature (PC) grade stake with blue and white flagging in lower center of picture).***

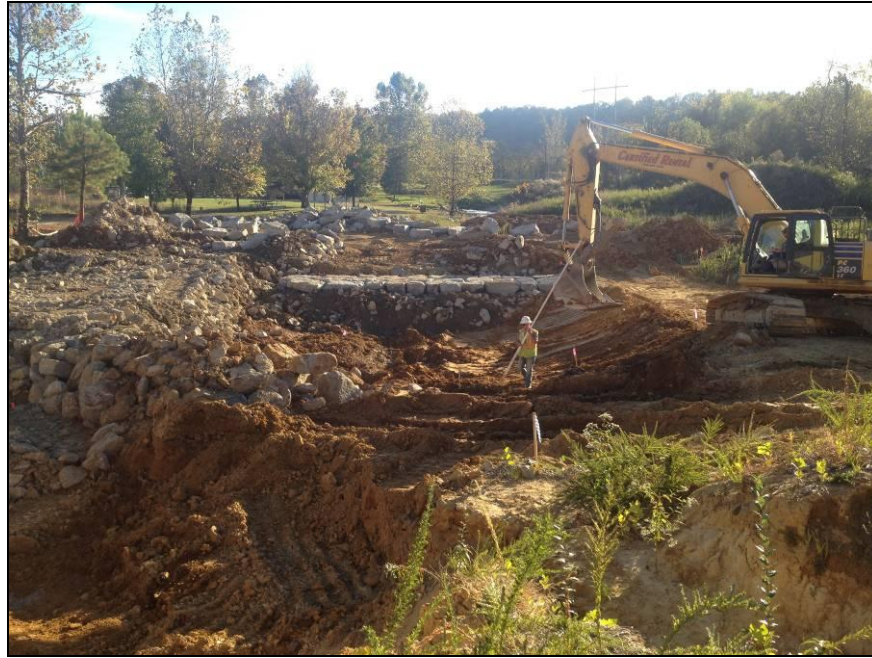
***Migration barrier splash pad constructed of 18" thick boulders in background. (Picture taken from approximate same location as above).***

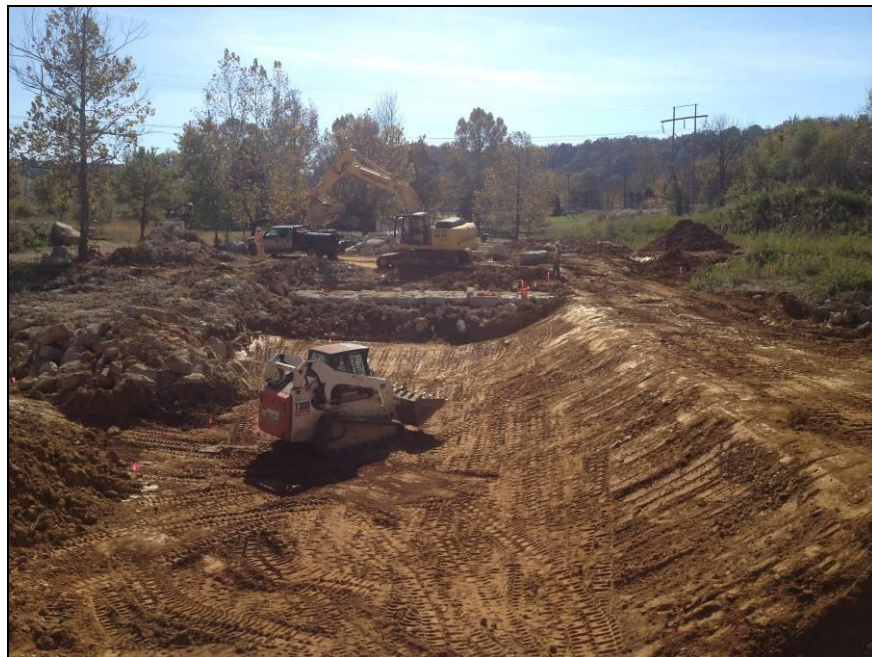
***Grading and smoothing soil in channel in preparation for liner installation across ravine spillway in right of picture. (Picture taken from approximate same location as above).***

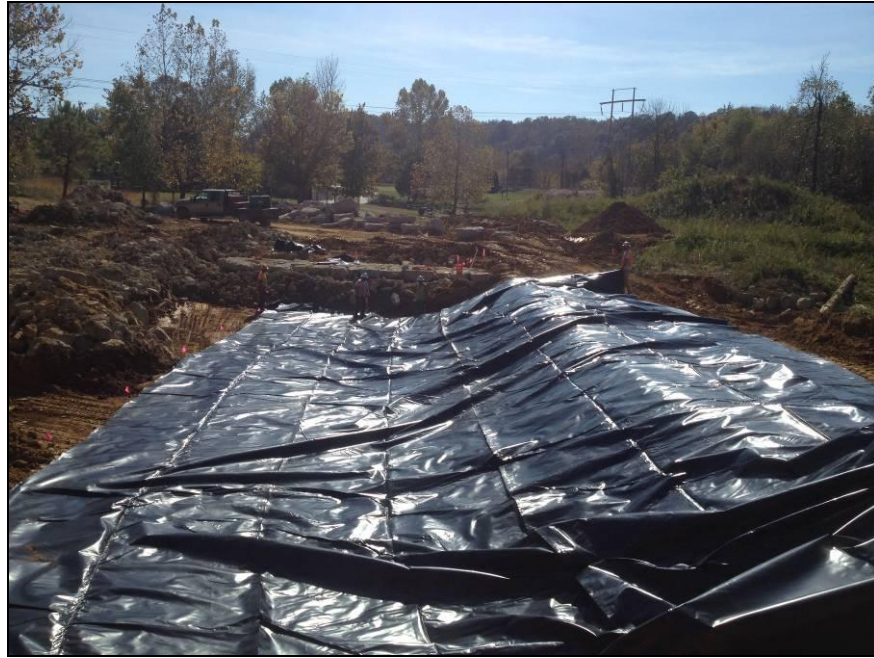
***Installing 30 mil HDPE liner across ravine spillway. (Picture taken from approximate same location as above).***

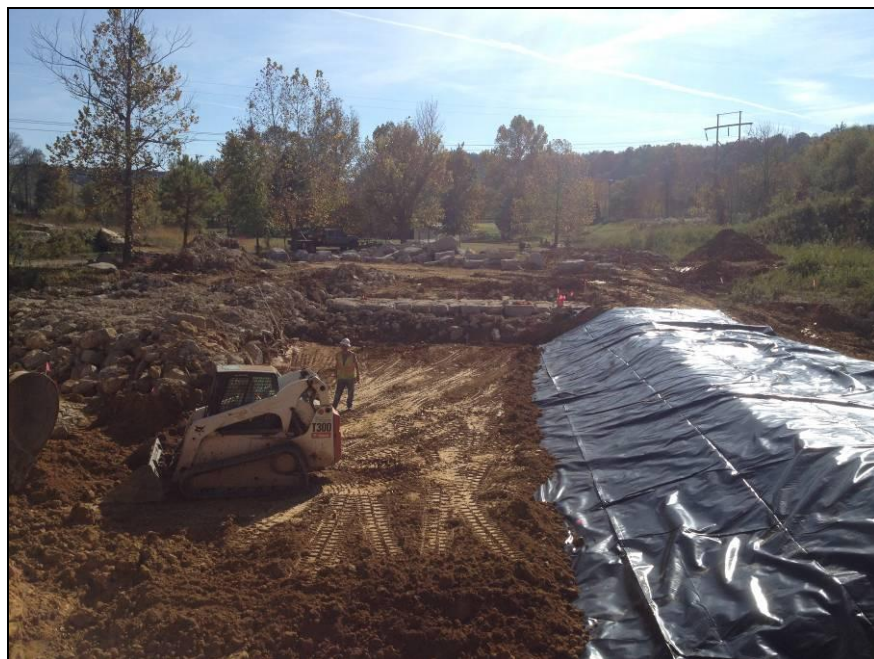
***Installing ~12" layer of clay over HDPE liner. (Picture taken from approximate same location as above).***

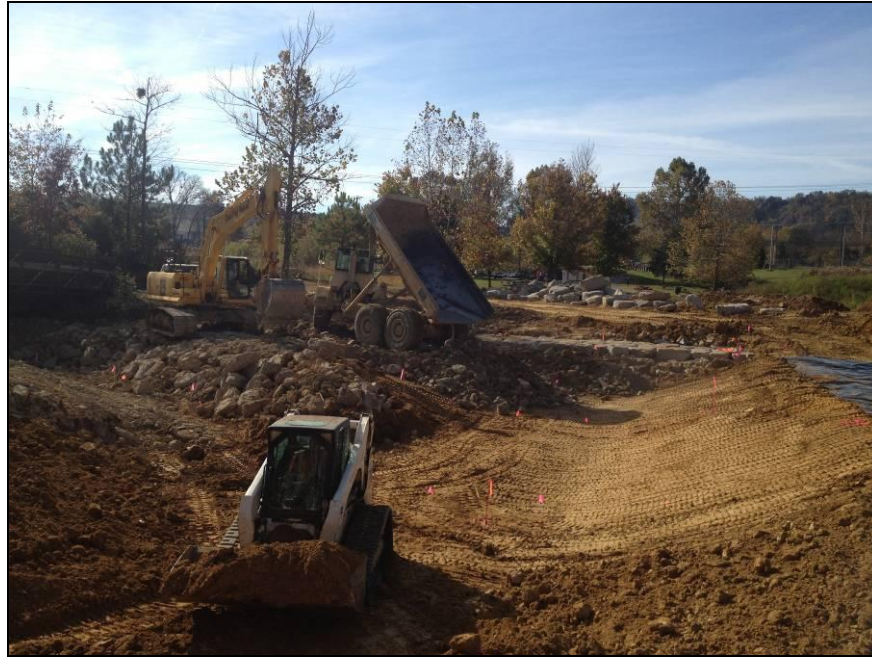
***Installing shot rock over clay and HDPE liner. (Picture taken from approximate same location as above).***

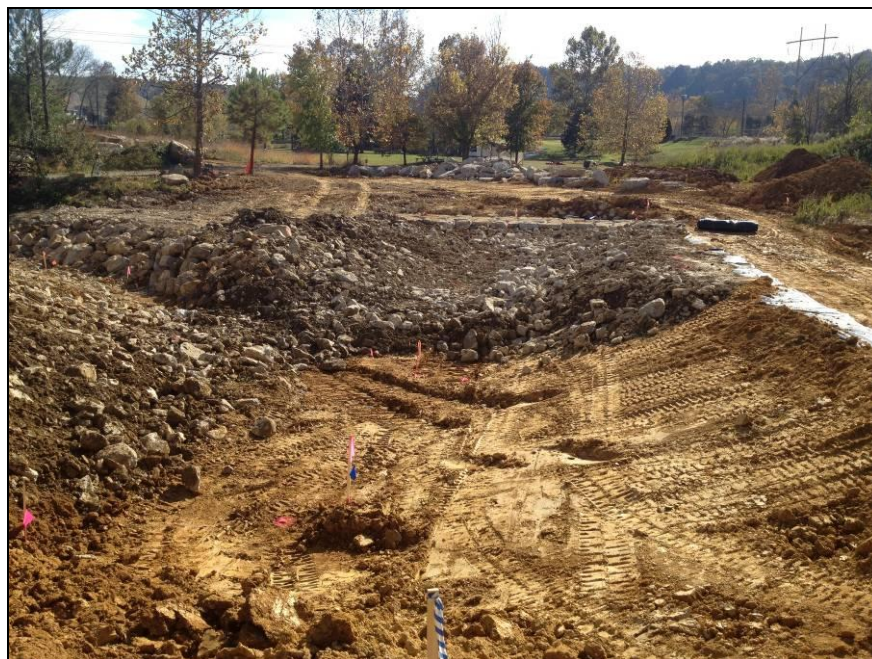
***Ravine (from left) and Hatchery Creek (in center) channels built with shot rock to confluence with each other. (Picture taken from approximate same location as above).***
